Collision with terrain involving Cessna 182, VH-TSA

Tomahawk, Tasmania | 20 January 2018

ATSB Transport Safety Report
Aviation Occurrence Investigation
AO-2018-008
Final – 15 February 2019

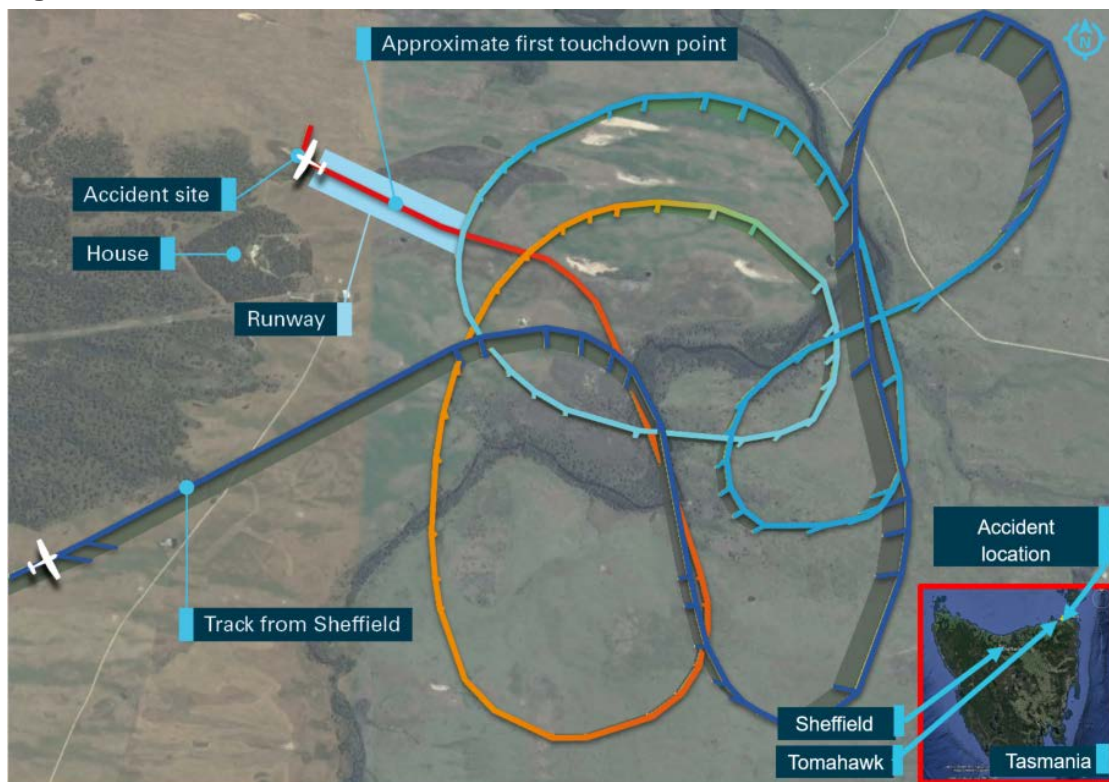
On arrival at Tomahawk, the pilot conducted a number of orbits to the right and left in the vicinity of the airfield (Figure 2). He reported that he manoeuvred the aircraft in that manner prior to approaching the runway because the aircraft was too high, and its groundspeed was faster than normal, for the approach.

Figure 1: Recorded aircraft track

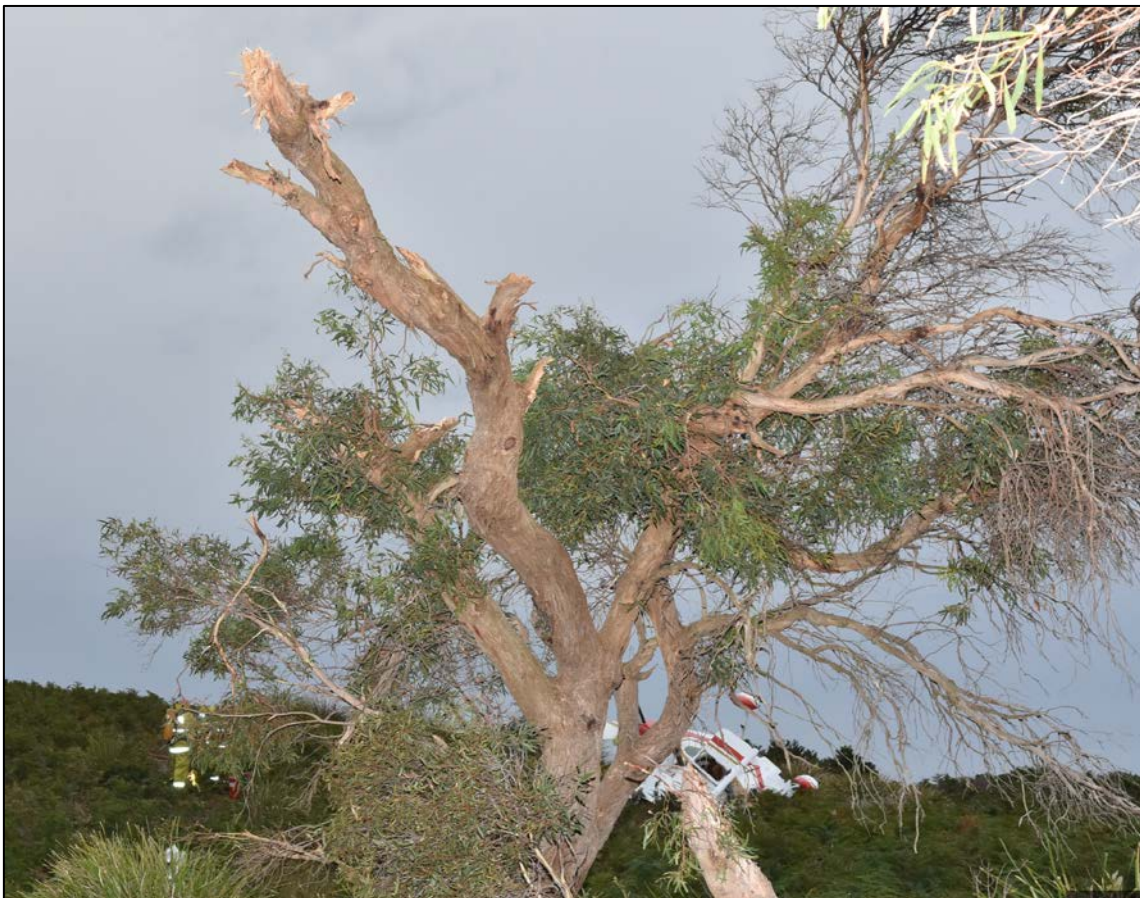
The aircraft started to climb, however it collided with a branch of the tree 5.6 m above the ground. The impact damaged the right wing, and the aircraft then collided with terrain and came to rest on its right side (Figures 2 and 3). The passenger sustained fatal injuries and the pilot was seriously injured. The aircraft was substantially damaged.

Figure 2: Accident site facing west, showing the tree branch struck by the aircraft’s right wing and the rising terrain in the background

Examination of the accident site and aircraft wreckage indicated that the aircraft's right wing struck the branch of a tree 5.6 m above, and about 36 m beyond, the end of the runway.

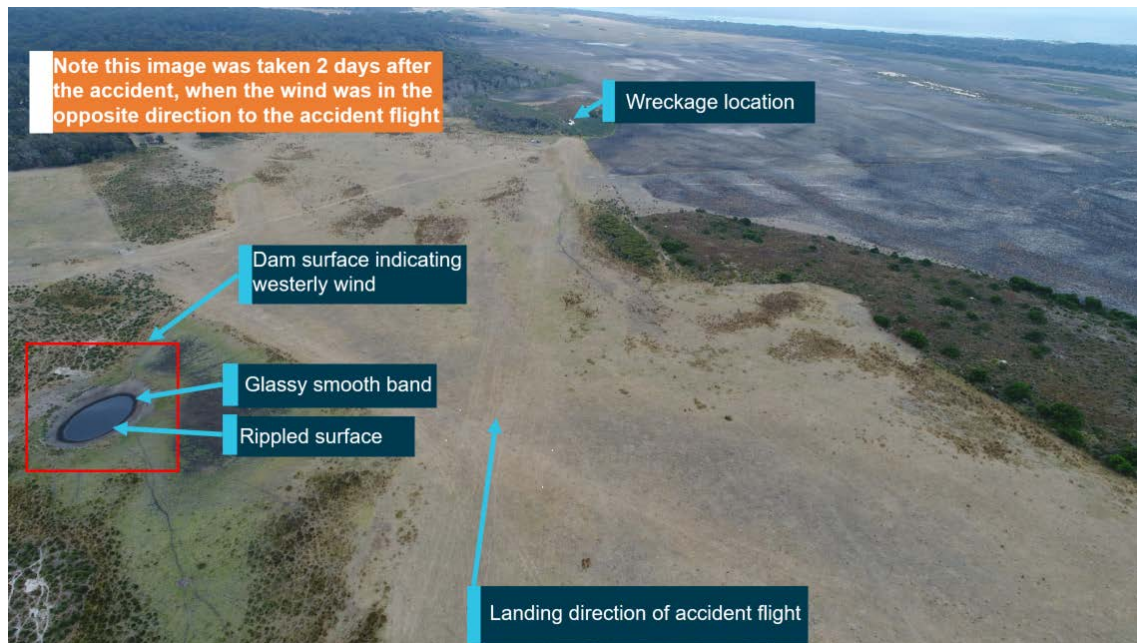
An aerodrome is defined as an area of land or water that is intended for use for the arrival, departure or movement of aircraft. The airfield in Tomahawk was a privately owned, non-controlled aircraft landing area and met the definition of an aerodrome. The prepared grass surface of the east-west runway was 717 m long, orientated in a direction of 281° magnetic, and had a short grass surface. The runway sloped down towards the west at an average slope of 1.5° for the first 500 m, and was then level. There was rising ground at both ends of the runway and a tree about 7 m high on the rising ground at the western end (Figure 3).

Although there was no windsock, other means were available by which the pilot could assess the local wind. These included the ability to observe the water surface pattern on several waterholes

in the circuit area, including the dam adjacent to the runways depicted in Figure 3, or a comparison of airspeed versus GPS groundspeed during the final approach.

Figure 3: Airfield looking in the landing direction (west) from runway threshold, showing dam surface. Note: image was taken 2 days after the accident, in a westerly wind

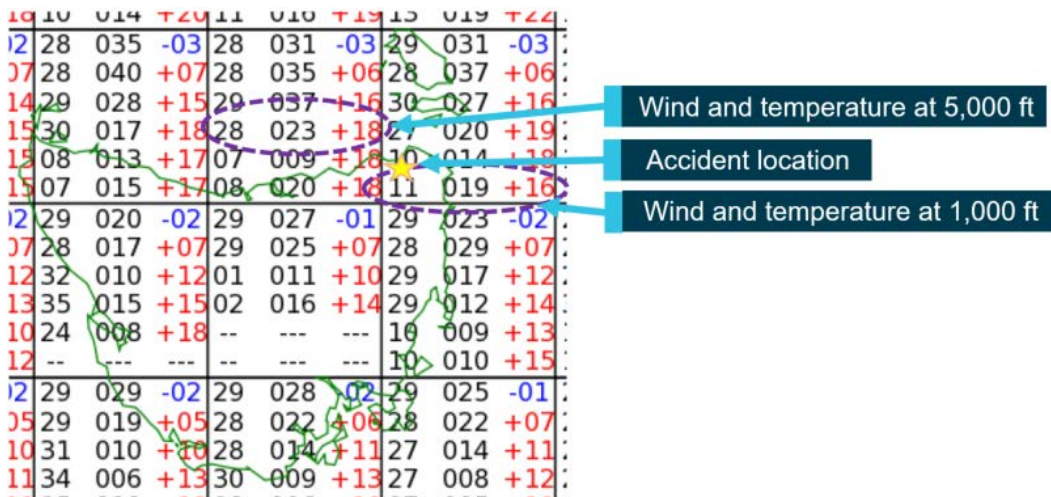
The BoM also identified that, due to a strong temperature inversion at about 4,500 ft AMSL, there were westerly winds above that level, with an easterly sea breeze below it. An extract of the forecast grid point wind and temperature chart valid for the flight is depicted in Figure 4.

The Tomahawk area is located in the top right grid and shows the wind at 1,000 ft above mean sea level (AMSL) was forecast to be from 110° true⁴ at 19 kt and temperature 16°C. In the top centre grid, where the aircraft was en route from Sheffield to Tomahawk at 3,500 ft, the forecast wind at 5,000 ft AMSL was from 280° true at 23 kt and temperature 18°C.

Figure 4: Grid point wind and temperature chart showing en route and destination forecast

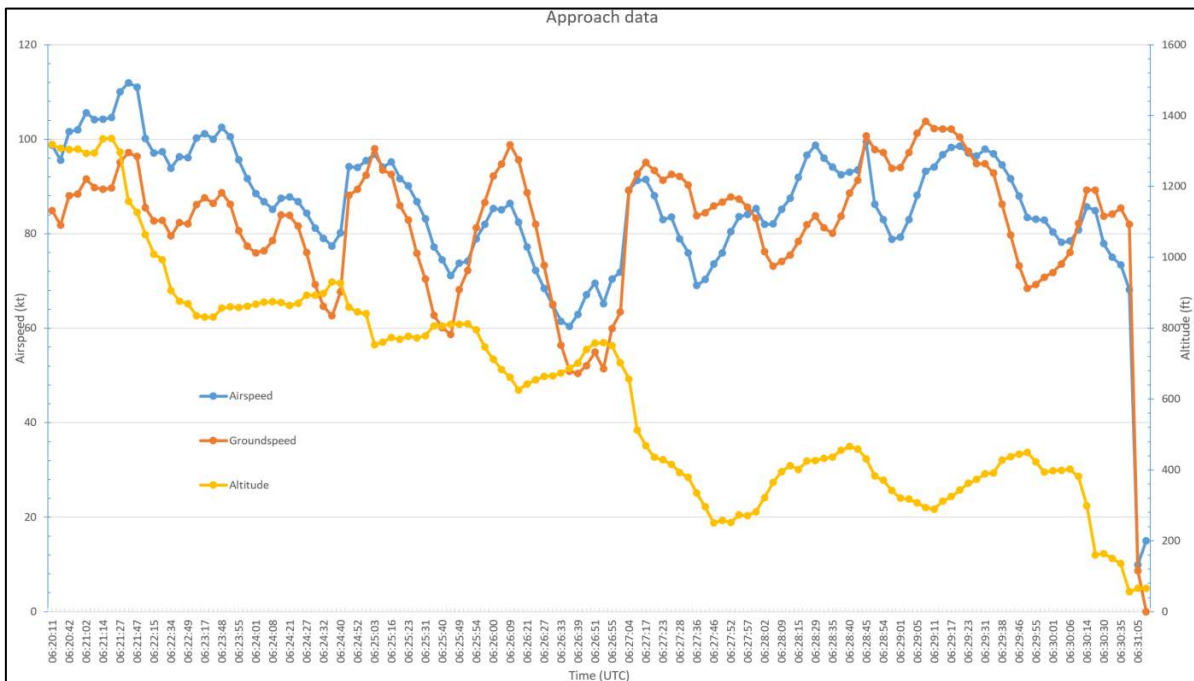
To estimate the aircraft’s airspeed from the recorded groundspeed, the ATSB applied a 15 kt easterly wind to the approach data. This showed that the airspeed varied between about 60-100 kt throughout the approach (Figure 5).

Figure 5: Approach data showing altitude, groundspeed and derived airspeed based on a 15 kt easterly wind

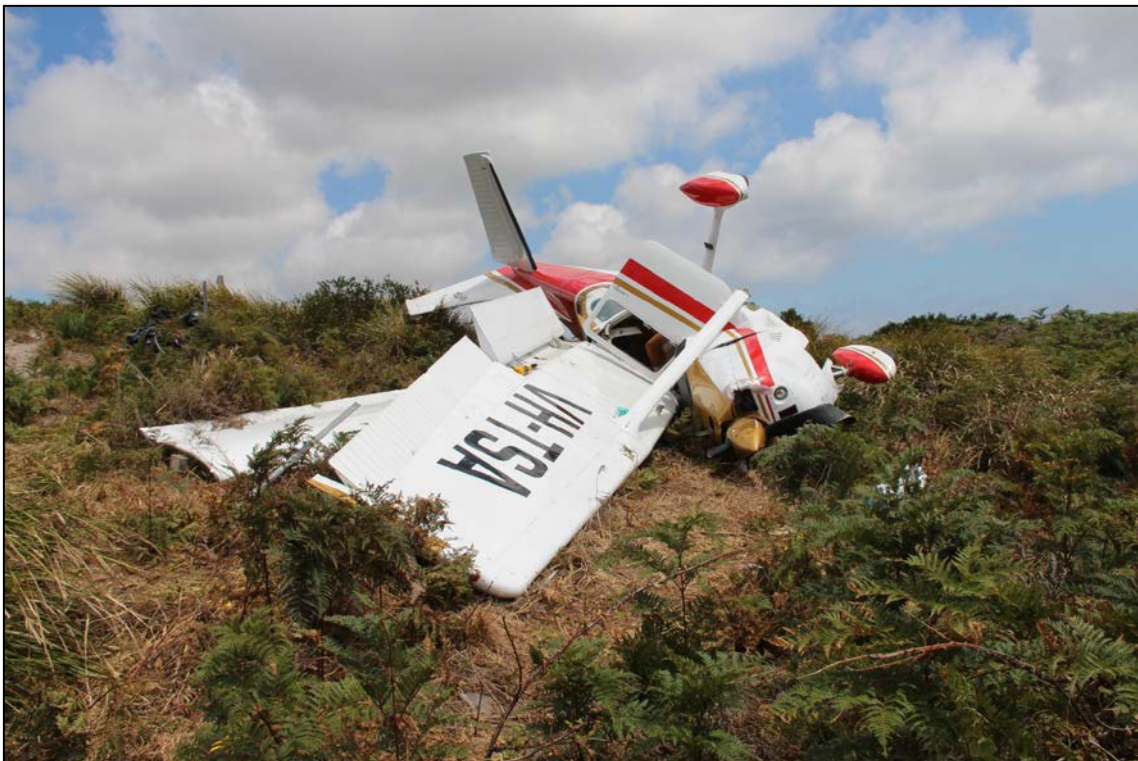
The right wing strut fractured on contact with the tree and separated from the aircraft. The wing failed, but remained connected to the fuselage. The aircraft subsequently rolled to the right and pitched nose-down. The propeller and the front of the engine struck the ground and the aircraft rotated about the impact point before coming to rest on its right side. During the impact sequence, the left wing strut fractured at the fuselage and the left wing came to rest on top of the right wing (Figure 5).

Fuel leaked from aircraft's ruptured wing fuel tanks, but there was no fire.

Examination of the aircraft did not identify any pre-existing faults and the pilot reported that the aircraft, including the engine, was operating normally at the time of the accident. The bending and impact marks on the propeller blades indicated that the engine was producing significant power when the blades struck the ground.

The right flap detached following impact with the tree and the left flap was extended. The flap actuator extension indicated that the flaps were in the fully extended position of 40°.

Figure 5: Damage to VH-TSA
